Test Report

Product : Safety Lock Type Key Switch
Model No. : KSKG-51S-LCLR
Manufacturer /Address : Kun Hung Electric Co., Ltd. /
183, Hancheon-ro, Dongdaemun-gu, Seoul, 02534 Rep. of Korea

4. Test standard (method) used : IEC 60068-2-6: 2008, IEC 60068-2-27: 2008
: IEC 60529:1989+A1:1999+A2: 2013
Requested test standard by applicant (Section * 5.2)

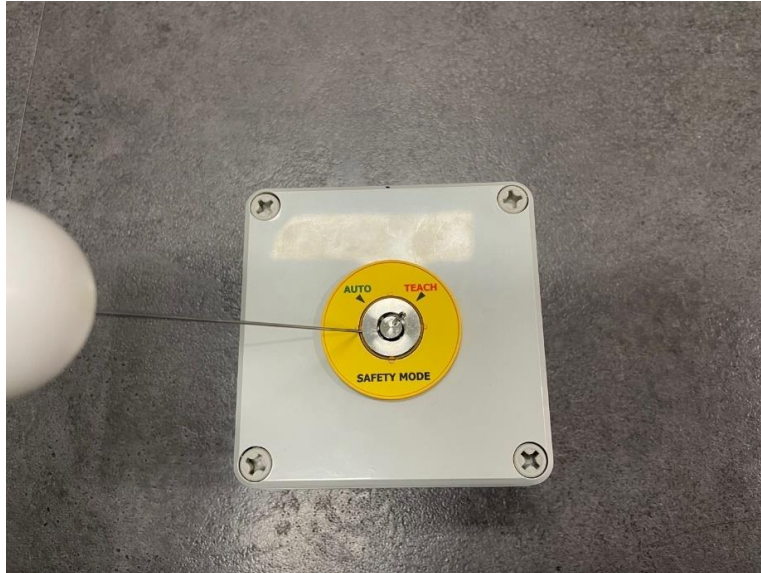
[The First characteristic numeral]

First characteristic numeral	Degree of protection	Remark
6	Protected against access to hazardous parts with a wire The access probe of 1,0 mm \varnothing shall not penetrate The test wire of 1,0 mm \varnothing shall not penetrate and adequate clearance shall be kept Test force : 1 N \pm 10 %	(Test conditions, see 5.1.6)

[Degrees of protection against access to hazardous parts indicated by the first characteristic numeral]

IP code	Part	Result
IP 6X	Access	There is no intrusion of the probe.
	Dust	No ingress of dust.
IP X6	Water	There is no water intrusion.

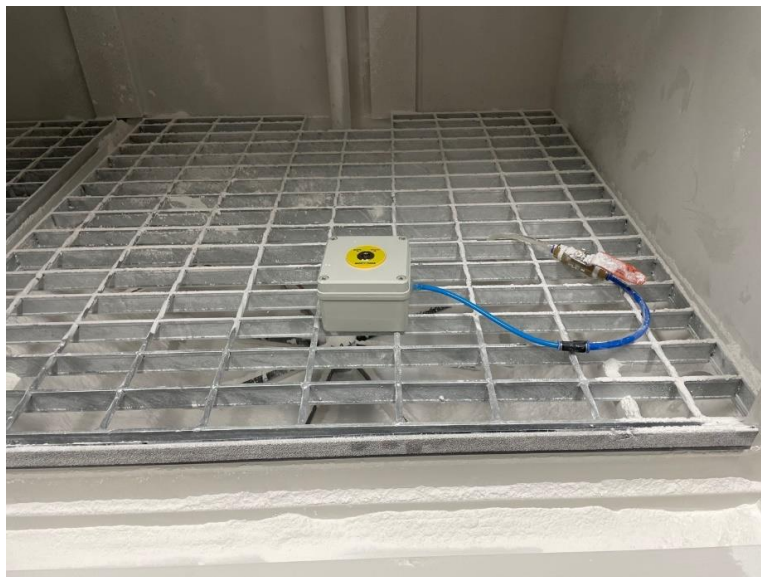
First characteristic numeral	Degree of protection	Remark
6	Dust-tight No ingress of dust The enclosure shall be deemed category 1, whether reductions in pressure below the atmospheric pressure are present or not. Product content volume : 907.5 cm ³ \rightarrow 0.91 L Target suction volume (80 times product volume) : 72.8 L Suction volume (maximum product volume 60 times / h) : 54.6 LPH \rightarrow 0.91 LPM Actual suction volume : 0.01 L Suction pressure (maximum 2 kPa) : 1.73 kPa Test time (maximum 8 h) : 8 h	(Test conditions, see 5.1.6)

[Degrees of protection against solid foreign objects indicated by the first characteristic numeral]

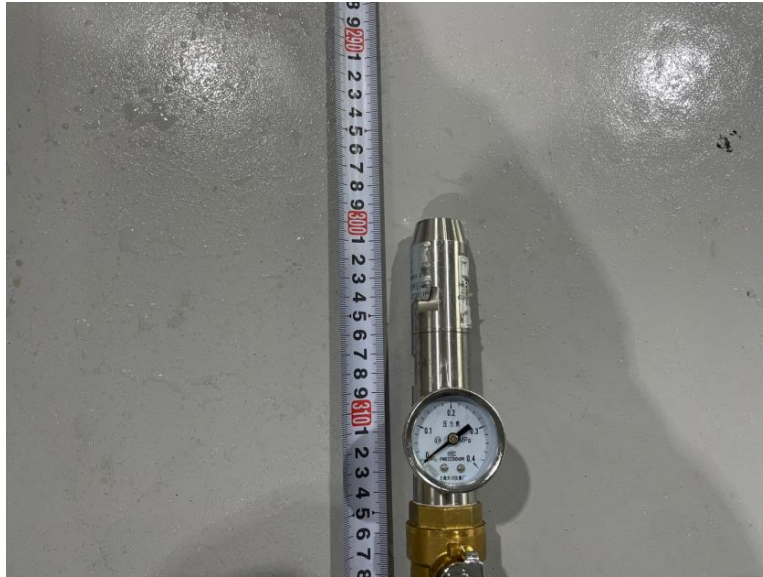
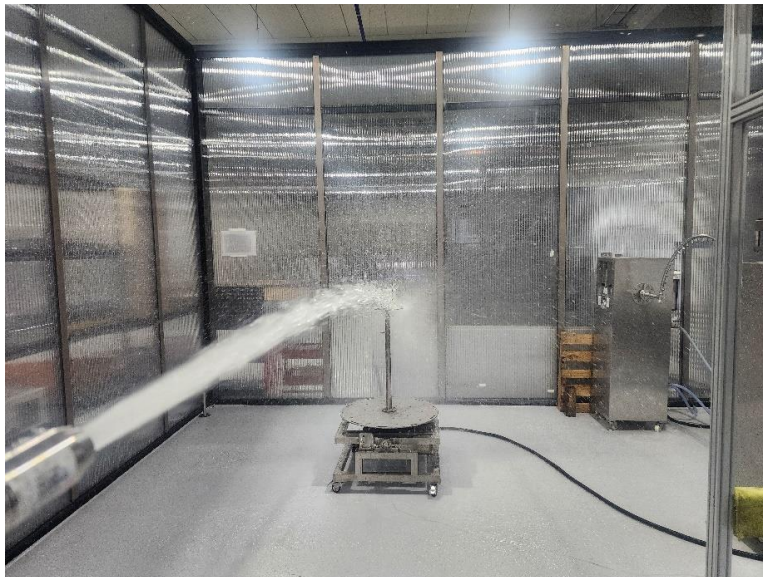
[The Second characteristic numeral]

Second characteristic numeral	Degree of protection	Remark
6	Protected against powerful water jets Water projected in powerful jets against the enclosure from any direction shall have no harmful effects Water flow rate: 100 L/min \pm 5 % distance 2.5 m to 3 m: 3 m Duration of test: 1 min/m ² at least 3 min: 3 min	(Test conditions, see 5.1.6)

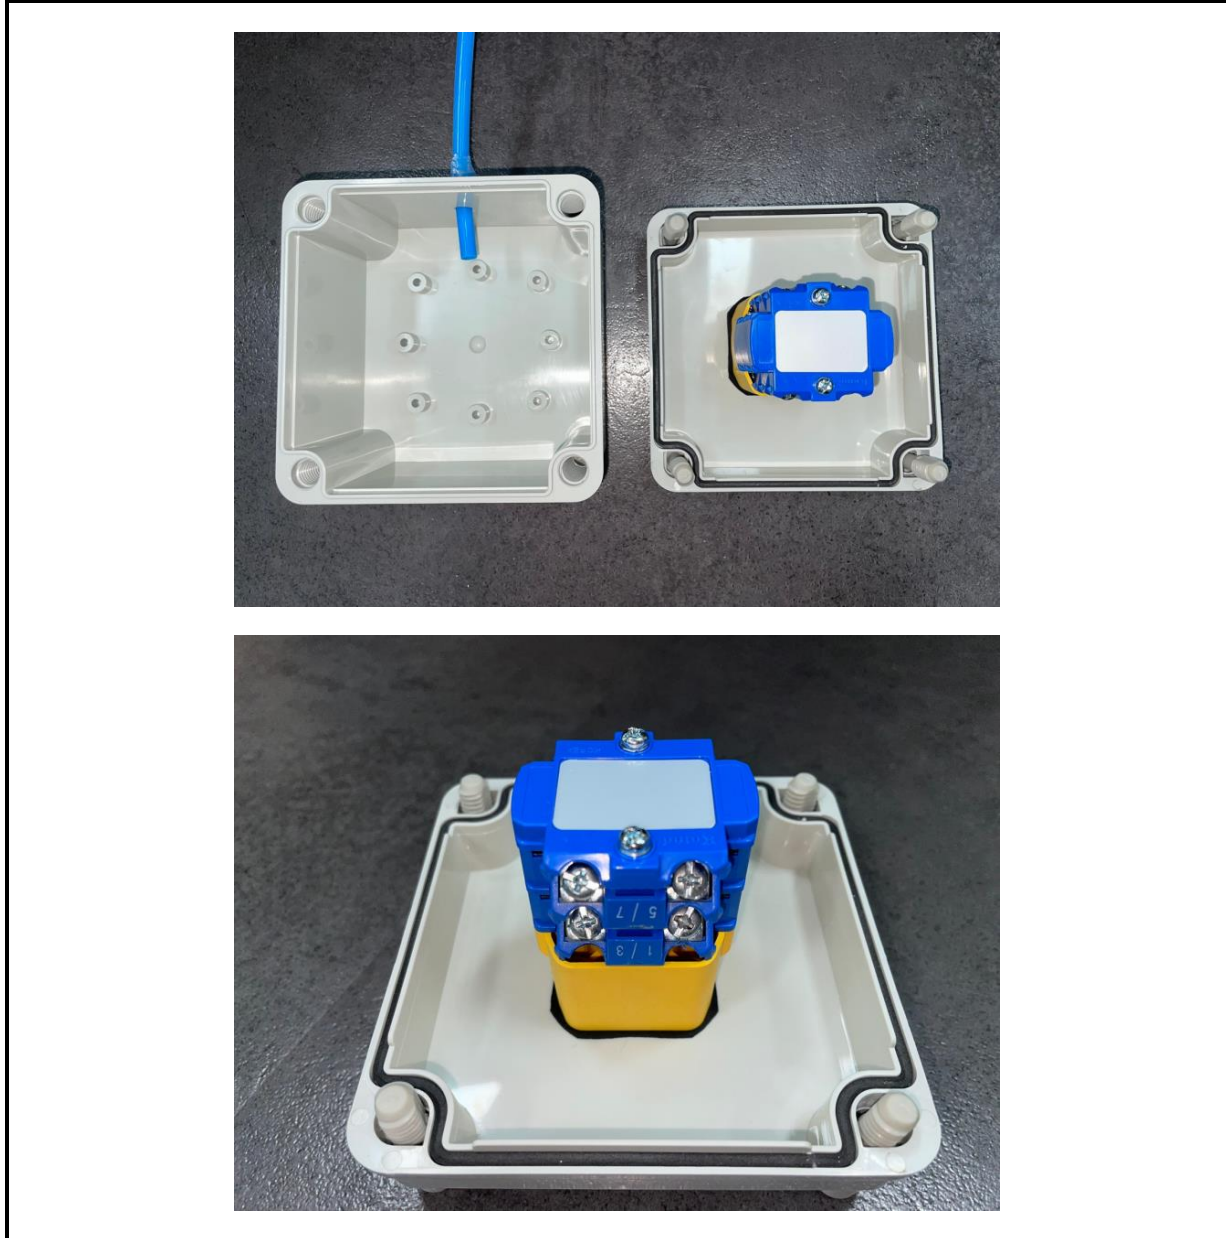
[The First characteristic numeral]

5.1.5. Internal photo after the test

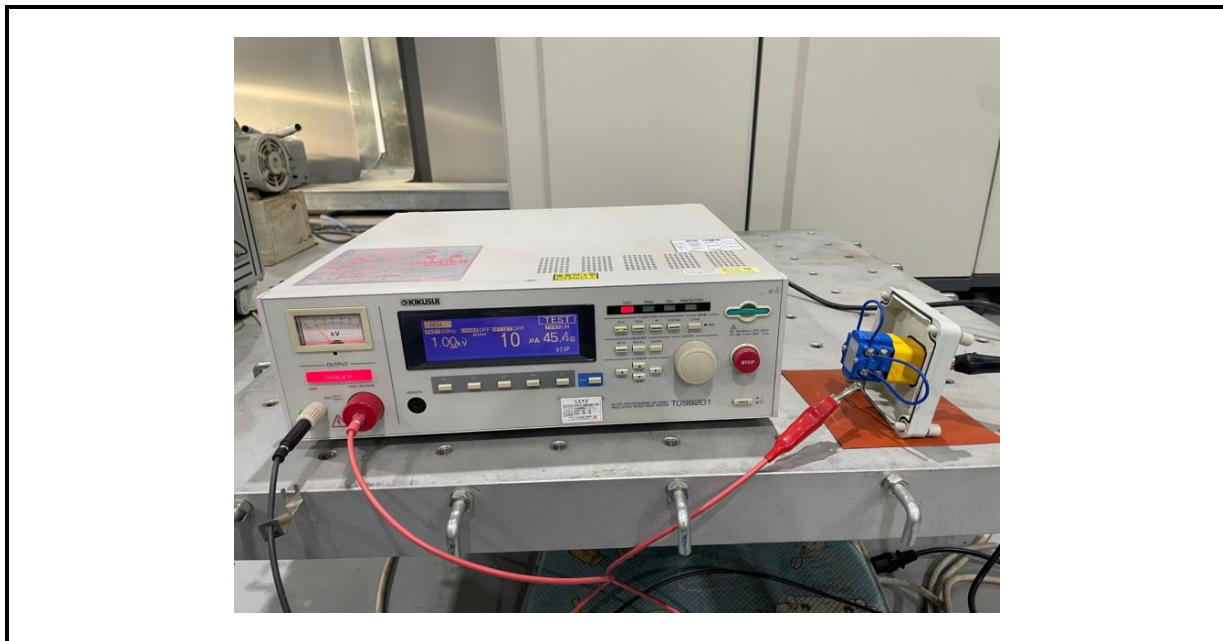
5.2.4. Test photo

Authorized location	applied voltage [V a.c]	Authorization time [s]	Test standards
Conductive part and frame	1 000	60	If applied at 1 000 V, 60 Hz for 60 s, there shall be no defects in insulation breakdown or use. (Cut off Current : 100 mA)

Test voltage [V a.c]	Test time [s]	Test result
1 000	60	No abnormality was found

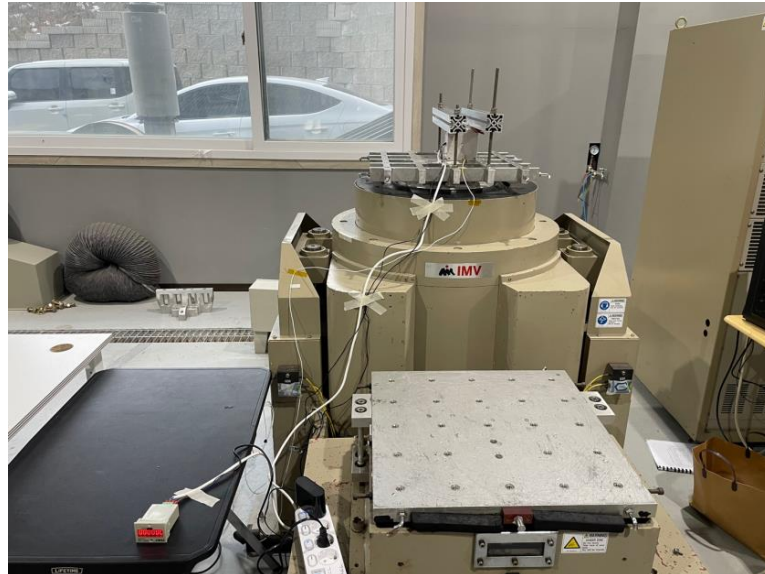
[X axis]

Item	Test Condition
Acceleration (m/s^2 , g)	15 g
Duration (ms)	11 ms
Number of shocks	6 shocks applied in each direction along three mutually perpendicular axes (a total of 36 shocks)
Test type	$\pm X$, $\pm Y$, $\pm Z$ axis
Number of samples	1 EA

Test Item	Test result
1. Visual inspection / Visual examination – Check damage, breakdown.	No abnormality was found
2. Performance check	No abnormality was found

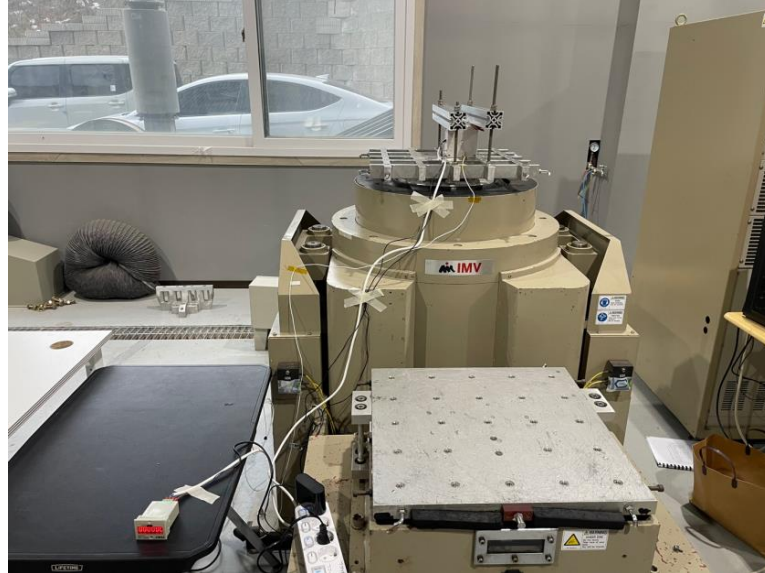
[X axis]

Item	Test Condition
Frequency	(10 ~ 55) Hz
Displacement(p-p)	0.5 mm
Sweep rate	5 min per single-sweep
Test time	30 min per axis
Test type	X, Y, Z axis
Number of samples	1 EA

Test Item	Test result
1. Visual inspection / Visual examination – Check damage, breakdown.	No abnormality was found
2. Performance check	No abnormality was found
