TEST REPORT

Report No : DRCREL1605-0206
Pages : (1) / (23) page

3. Product Name (Model / Serial No.) : Emergency Stop Switch (KSEB-30 Series / -)

7. Test Result : Refer to the attached document

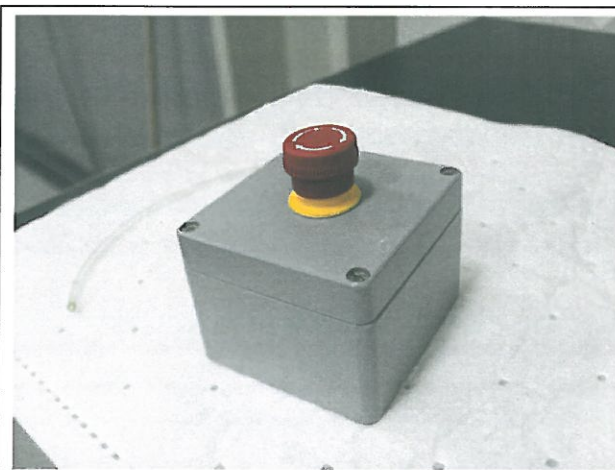
a. IP66 Product

[Photo 1. Emergency Stop Switch]

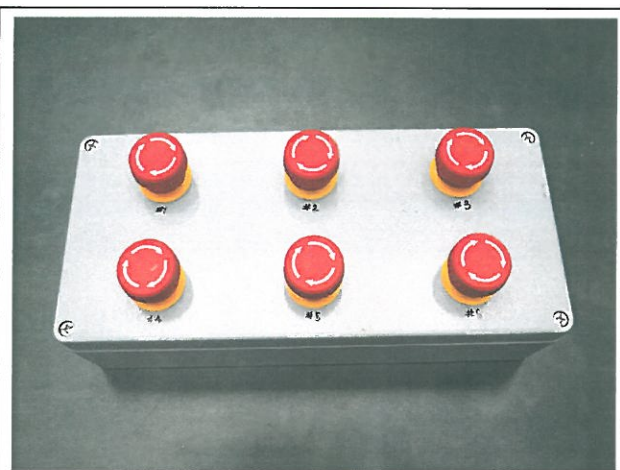
b. Vibration Product

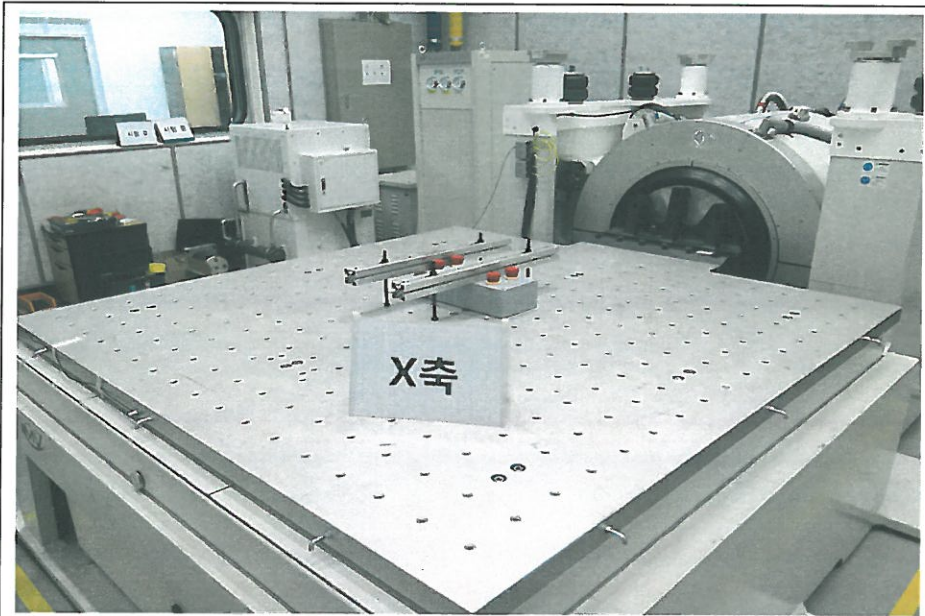
a. X-axis

[Photo 2. Test photograph]

- 1) Perform the visual inspection check of the test specimen.
- 2) Fixed the test specimen on the test table.
- 3) Perform the vibration test in accordance with test condition.
- 4) Perform the test for the 3-axis. (X, Y, Z)
- 5) Perform the visual inspection check of the test specimen.

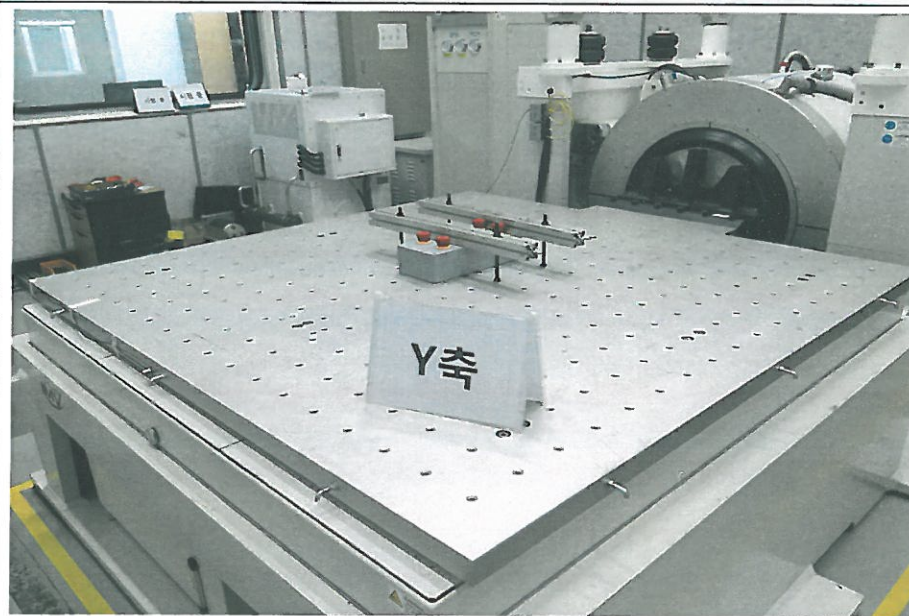
b. Y-axis

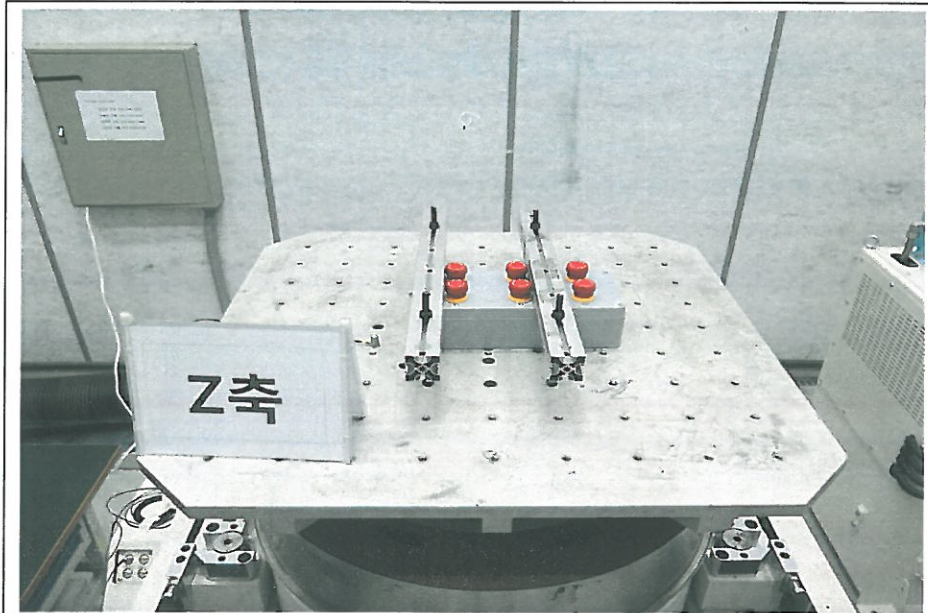
c. Z-axis

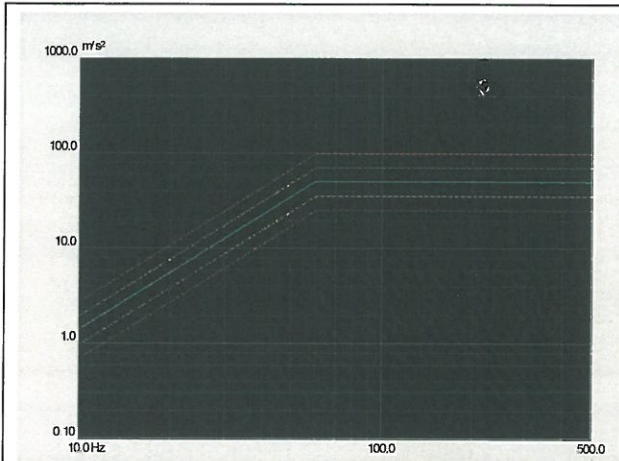
a. X-axis

[Photo 3. Test profile]

Frequency (Hz)	Acceleration (m/s ²)	Displacement (mm)
(10 ~ 60.15)	-	0.7 (p-p)
(60.15 ~ 500)	50 (0-p)	-

- 3) Sweep rate : 1 oct/min
- 4) Test cycle : 10 cycles
- 5) Test time : 1 h 52 min in each axis
- 6) Test axis : X-axis, Y-axis, Z-axis
- 7) Total test time : 5 h 36 min
- 8) Sample check : Before the test and after the test visual check
- 9) Sample condition : ① Unpackaged ② Non-operation
- 10) Sample quantity : 1 Set (6 ea)

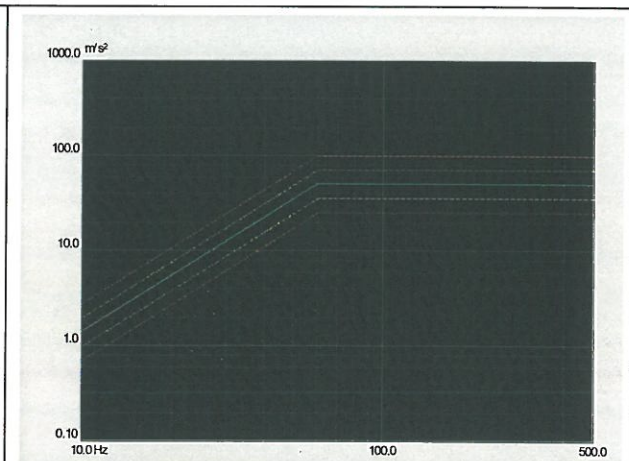
b. Y-axis

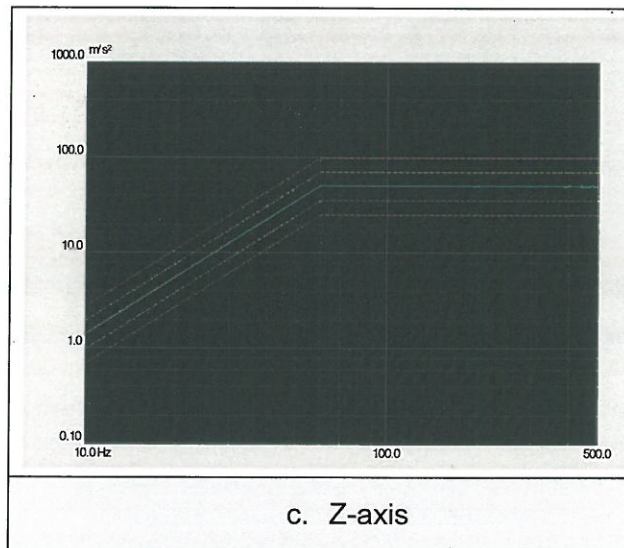
c. Z-axis

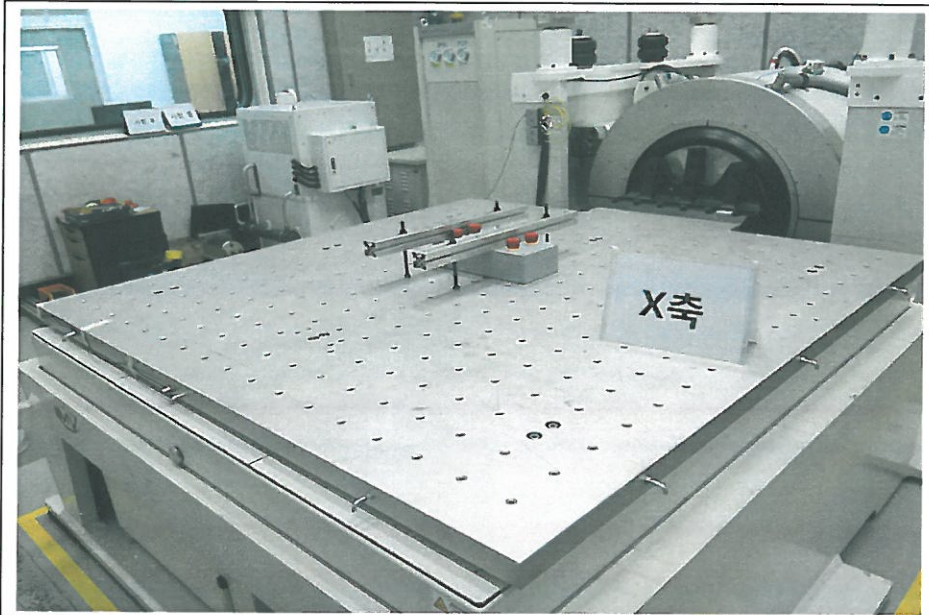
a. \pm X-axis

[Photo 4. Test photograph]

- 1) Perform the visual inspection check of the test specimen.
- 2) Fixed the test specimen on the test table.
- 3) Perform the shock test in accordance with test condition.
- 4) Perform the test for the 3-axis. ($\pm X$, $\pm Y$, $\pm Z$)
- 5) Perform the visual inspection check of the test specimen.

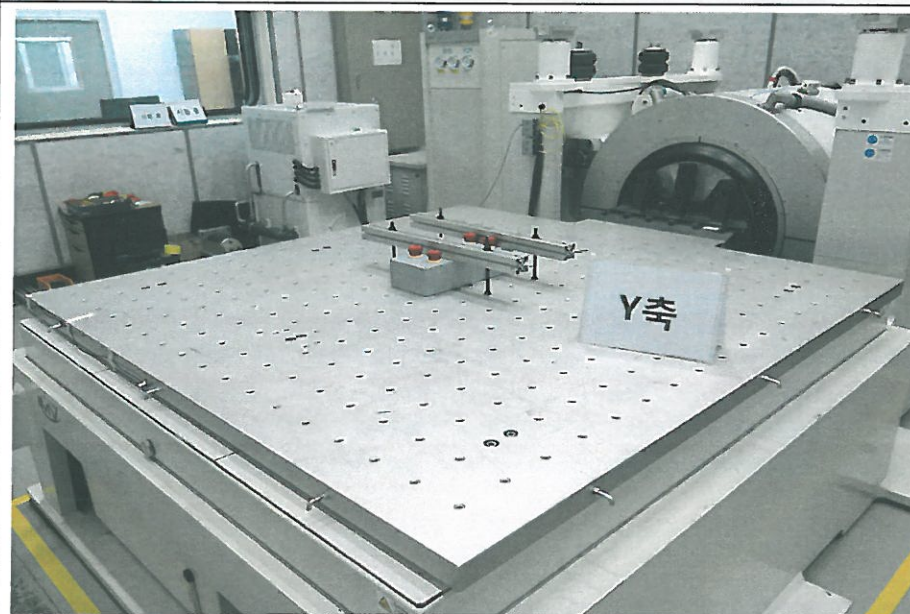
b. \pm Y-axis

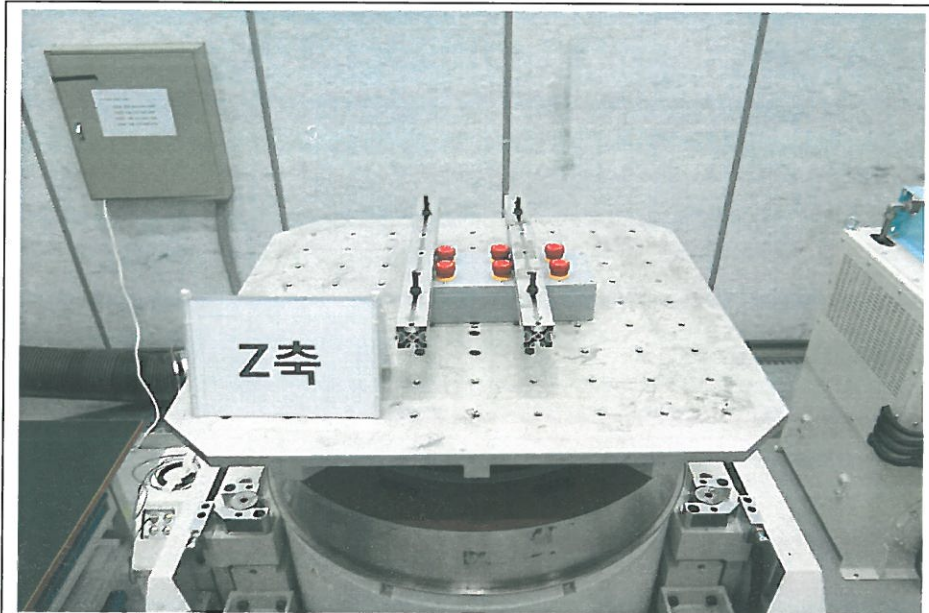
c. $\pm Z$ -axis

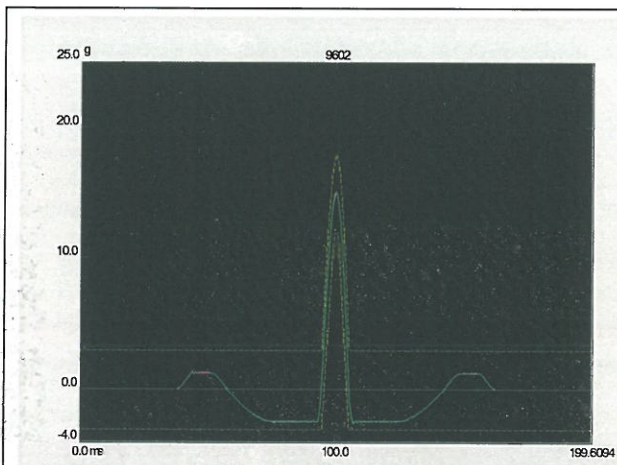
a. X-axis (Positive)

[Photo 5. Test profile]

- 1) Test type : Half sine
- 2) Acceleration : 15 g
- 3) Duration time : 11 ms
- 4) Test time : 3 times in each axis
- 5) Test axis : $\pm X$ -axis, $\pm Y$ -axis, $\pm Z$ -axis
- 6) Total test time : 18 times
- 7) Sample check : Before the test and after the test visual check
- 8) Sample condition : ① Unpackaged ② Non-Operation
- 9) Sample quantity : 1 Set (6 ea)

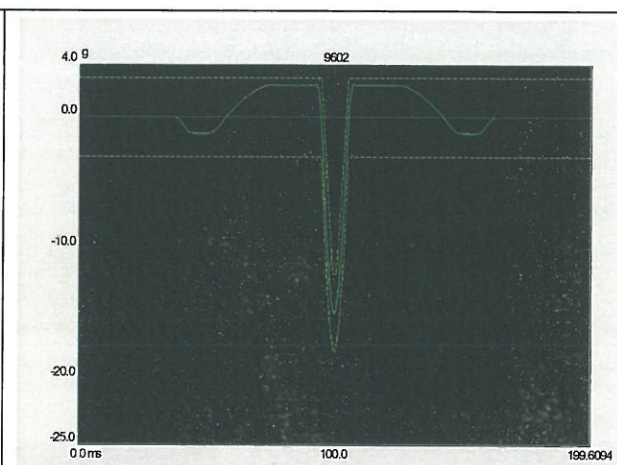
b. X-axis (Negative)

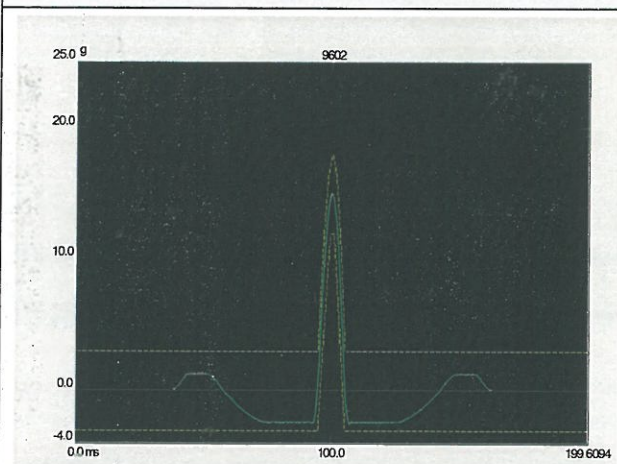
c. Y-axis (Positive)

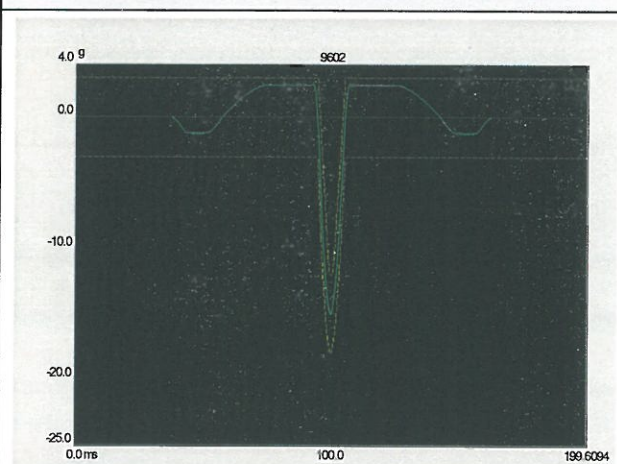
d. Y-axis (Negative)

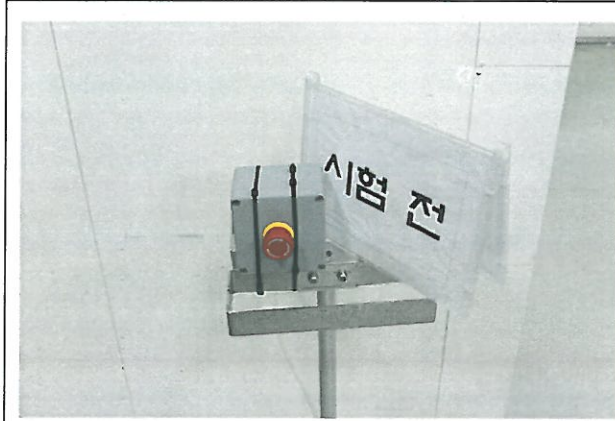
a. Before the test

[Photo 6. Test photograph]

- 1) IP Code : IPX6 (Protected against powerful water jets)
- 2) Waterproof rate: 100 x (1 ± 5 %) L/min
- 3) Spray distance : (2.5 ~ 3.0) m
- 4) Test time : 3 min
- 5) Sample condition : ① Unpackaged ② Non-operation
- 6) Sample quantity : 1 ea

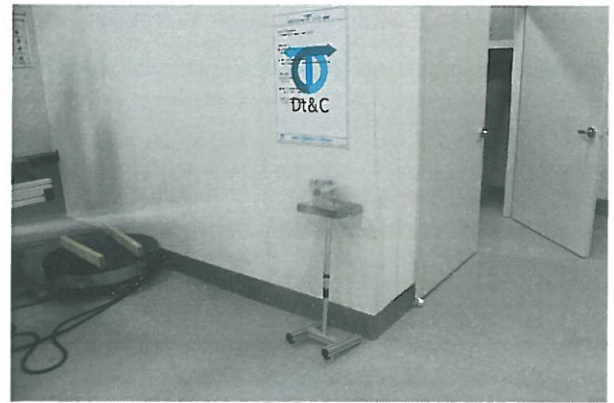
b. During the test

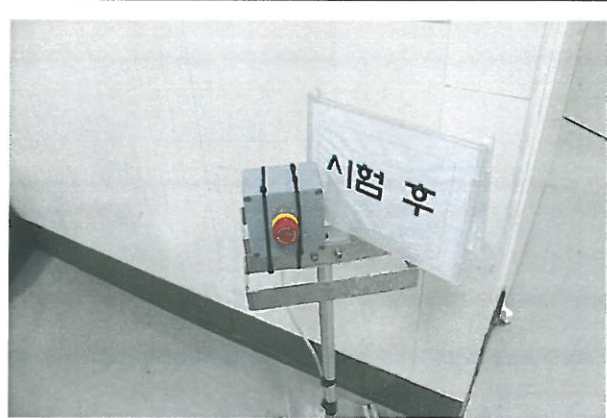
c. After the test

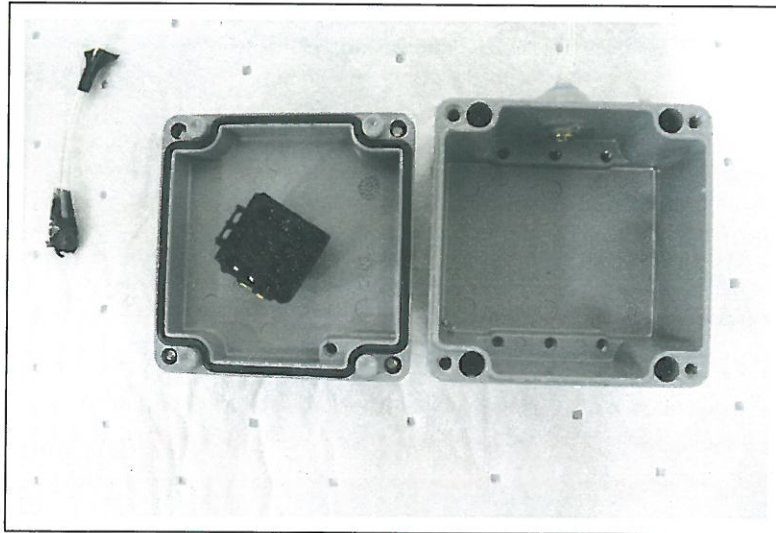
[Photo 8. IPX6 Test result]

Check list	Test result
Confirmation of dust penetration	No dust penetration was found (Refer to ※ Appendix 1.)

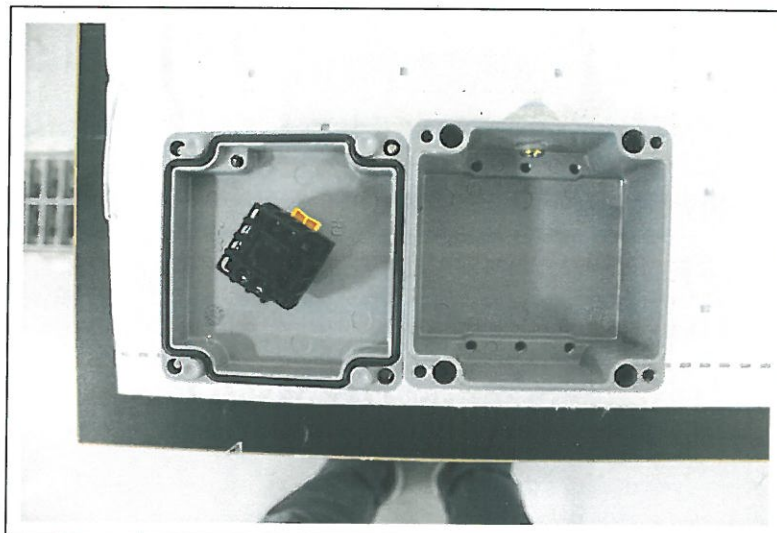
[Photo 9. IP6X Test result]

Check list	Test result
Confirmation of dust penetration	No dust penetration was found (Refer to ※ Appendix 1.)
